## FIELD INSPECTION

<b>Project Name:</b>	Mountain Valley Pipeline	<b>Inspector:</b>	Matthew Grant
<b>Inspection Date:</b>	Tuesday, February 26, 2019	<b>Project Contact:</b>	Brian Clauto
<b>Spread: Montgomery County MP 227 St#12035+19 &amp; 12031+56 MP 228 St#12076+95</b>	Spread H	<b>Weather (Wet/Dry/Rain):</b>	Dry

## FIELD INSPECTION PHOTO LOG

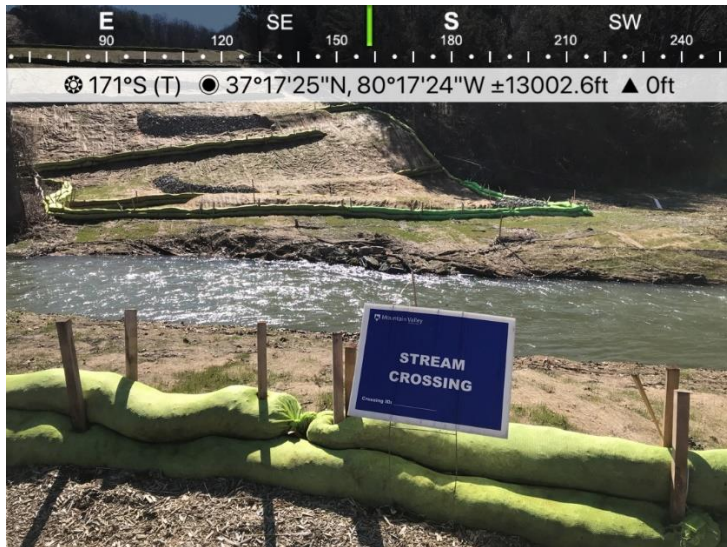
- Fig. 1 Area near designated stream S-G36 has been temporarily stabilized and controls are in place.

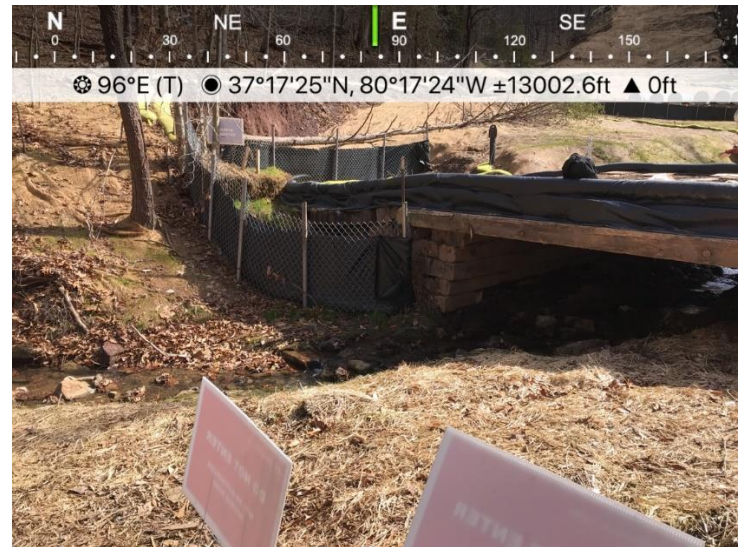
- Fig. 2 Area near designated stream S-G40 has been temporarily stabilized and controls are in place.

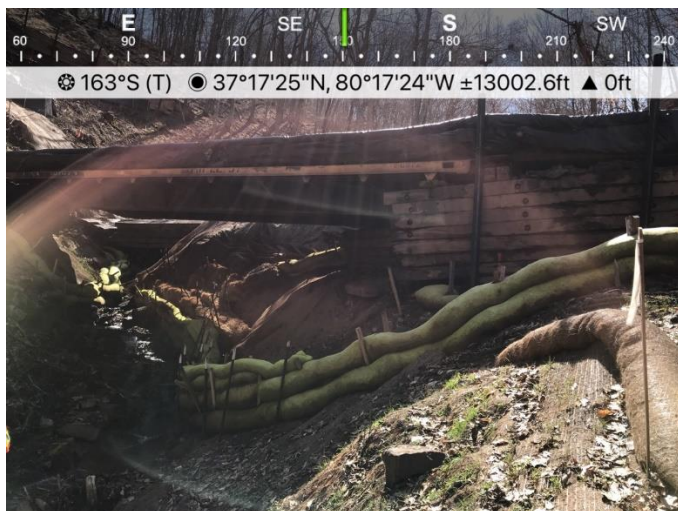
- Inspected designated streams included: S-G36, S-G38, and S-G40. All ECD were in place near all the streams, no impacts were observed at the time of the inspection.
- At designated stream S-G39 triple stack at stream bank required re installation and had been previously reported in extended corrective actions required, crews were on site for the repair on 2-27-19. No impacts were observed at the time of the inspection.

- Fig. 3 Area near designated stream S-G39 has been temporarily stabilized and triple stack was noted for repair.

**Recommended Corrective Action:** Maintain all controls per the annual standards and specs.

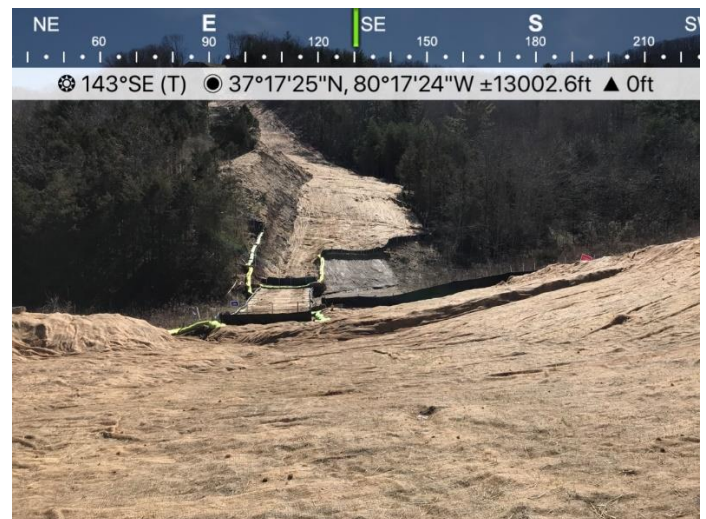
- Fig. 4 Area near designated stream S-G38 has been temporarily stabilized and controls are in place.
